Subj: U.S. NAVAL SUPPORT ACTIVITY, NAPLES, ITALY SUPPORT SITE CHILD DEVELOPMENT CENTER DRINKING WATER

Overview of Testing Results for Lead in Drinking Water and Corrective Actions for NSA Naples Support Site Child Development Center (CDC) (Building 2065)

Summary Results Table
Priority Areas Lead Testing and Corrective Actions (2021)
NSA NAPLES Support Site Child Development Center
Bldg. 2065

NSA NAPLES
2021 STEP 2 DRINKING WATER SAMPLING FOR LEAD IN PRIORITY AREAS
SUPPORT SITE CHILD DEVELOPMENT CENTER
BLDG. 2065
GROUND FLOOR

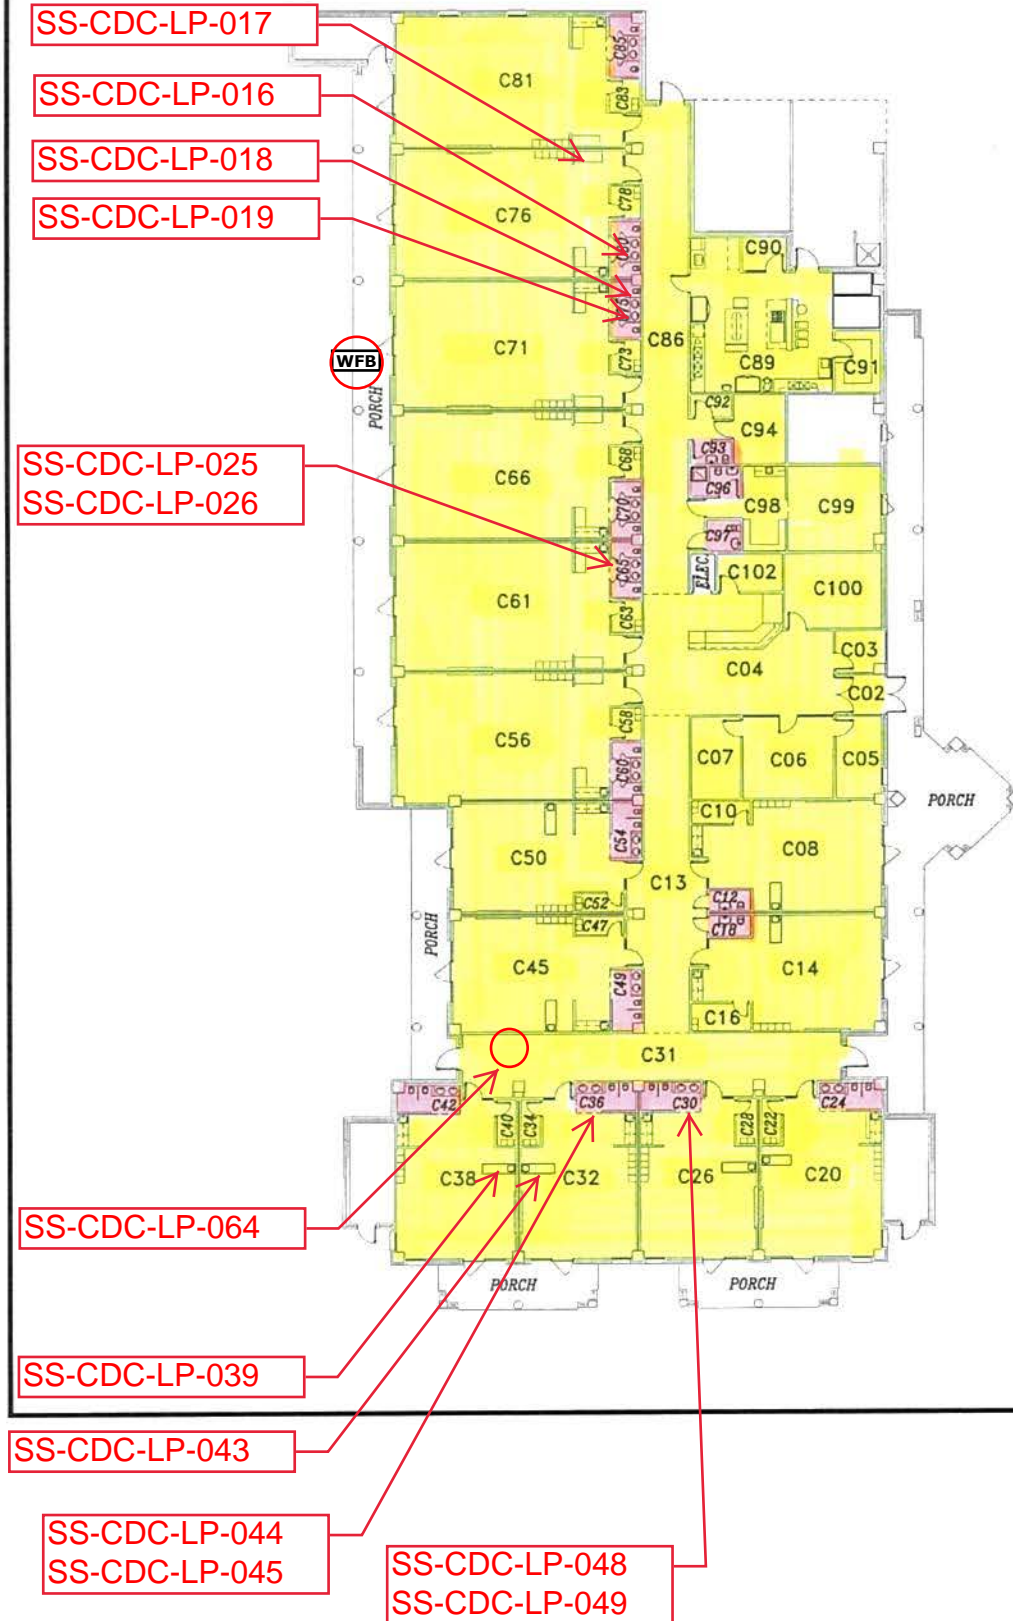
3. The lead levels were higher than the screening level at sinks in rooms C-80, C-76, C-75 (two outlets), C-65 (two outlets), C-38, C-32, C-36 (two outlets), C-30 (two outlets) and C-38 hallway. After receiving the test results, we immediately took these water outlets out of service. Details on the corrective actions we plan to take to reduce the amount of lead in water at these fixtures are discussed in the attached overview of results & actions. Also enclosed are complete test results and a floor plan of the CDC that indicates the location of the fixtures that had lead levels higher than the screening level.

A floor plan of the NSA Naples Support Site CDC has also been included to show the locations for the fixtures that exceeded 15 ppb.
