Subj: U.S. NAVAL SUPPORT ACTIVITY, NAPLES, ITALY SUPPORT SITE MIDDLE AND HIGH SCHOOL DRINKING WATER

Overview of Testing Results for Lead in Drinking Water and Corrective Actions for NSA Naples Support Site Middle/High School (Building 2058)

NSA NAPLES 2021 STEP 2
DRINKING WATER SAMPLING FOR LEAD IN PRIORITY AREAS

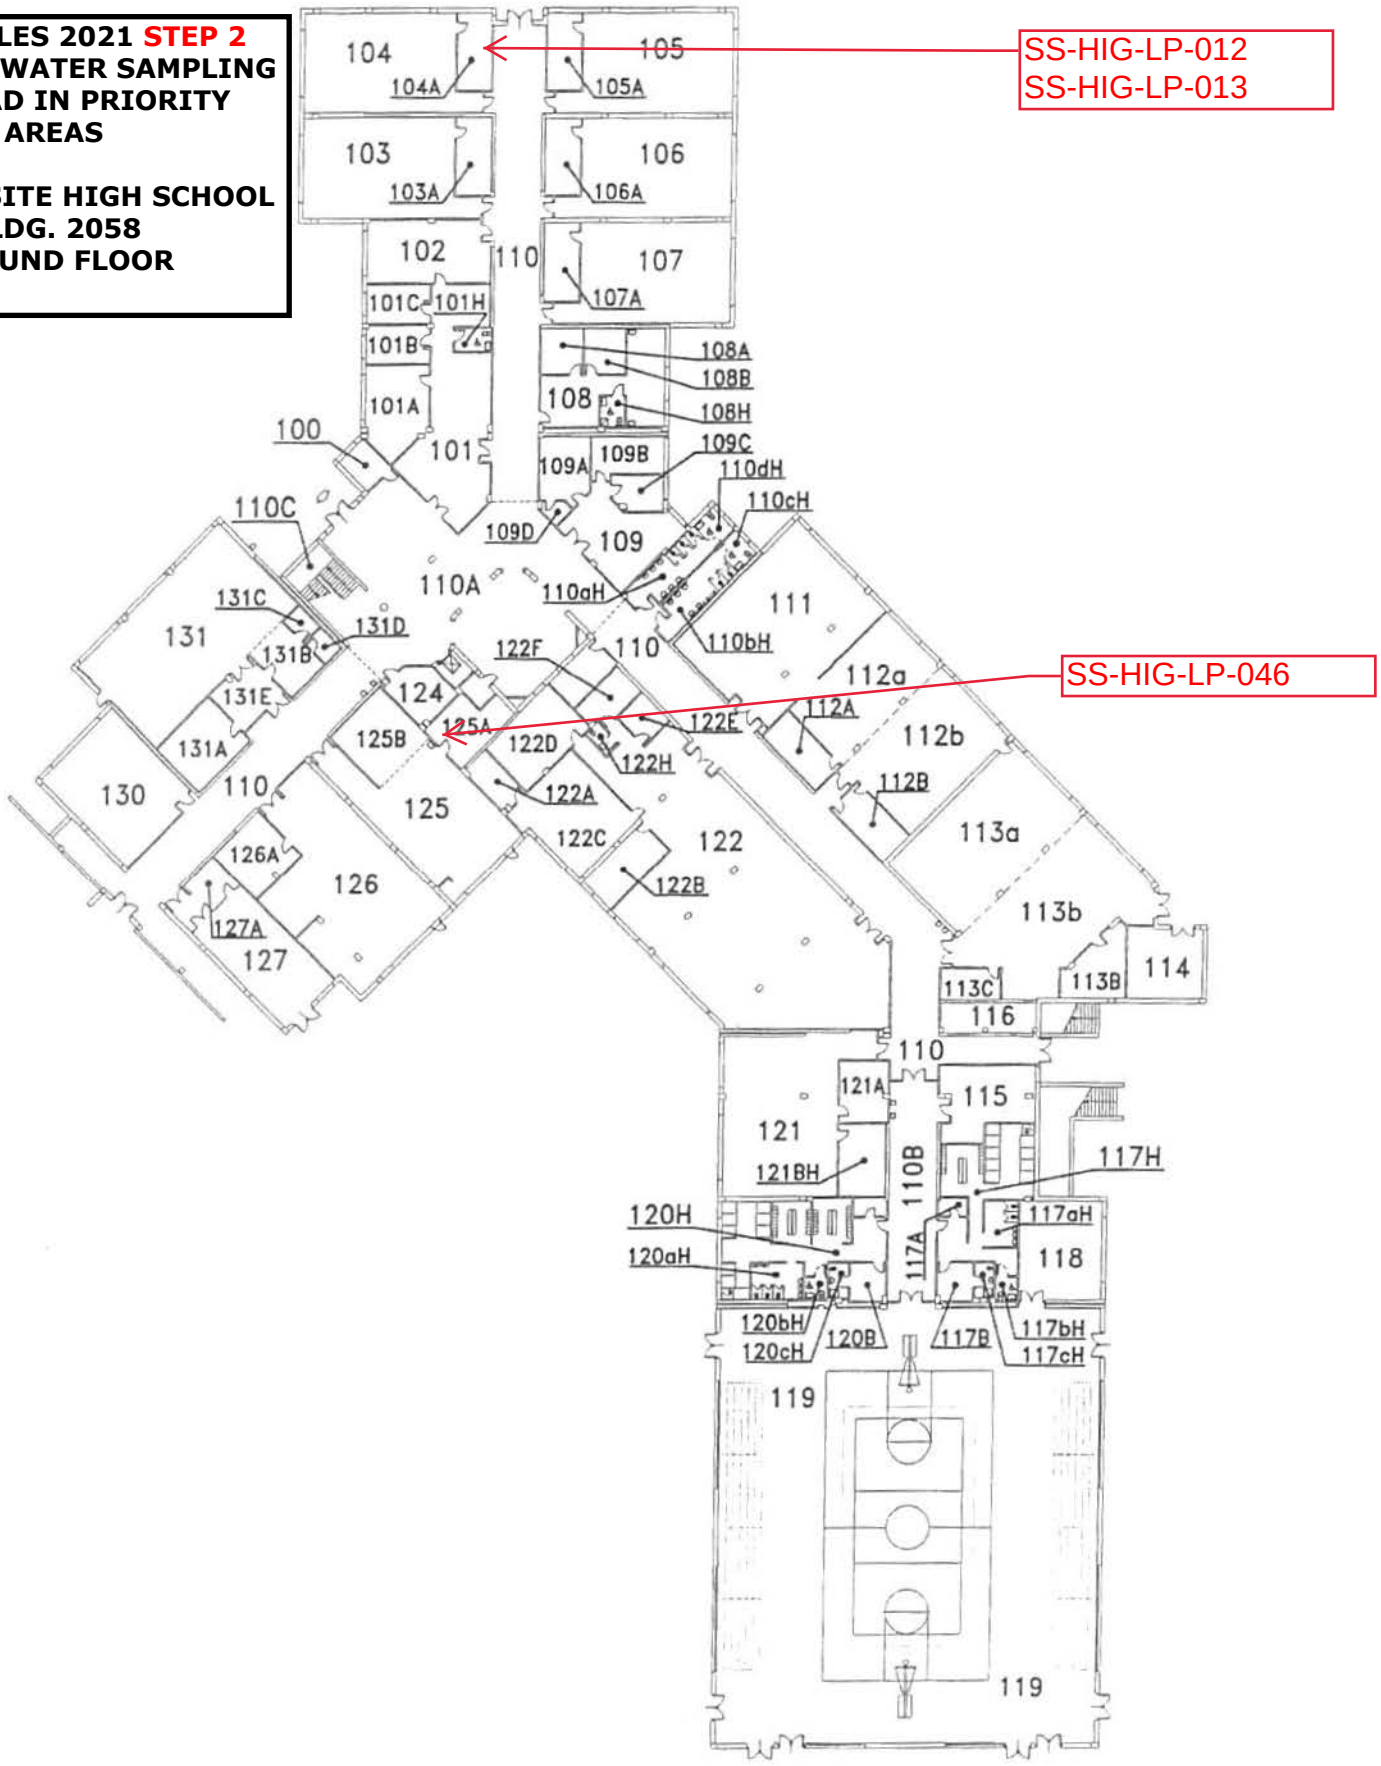
SUPPORT SITE HIGH SCHOOL
BLDG. 2058
GROUND FLOOR

3. The lead levels were higher than the screening level at sinks in rooms 104 (two outlets), and 125. After receiving the test results, we immediately took these water outlets out of service. Details on the corrective actions we plan to take to reduce the amount of lead in water at these fixtures are discussed in enclosure (1). Enclosure (2) indicates the location of the fixtures that had lead levels higher than the screening level.

The three outlets that exceeded the screening level of 15 ppb were student lab and bathroom sinks located in rooms 104 (two outlets) and 125, which tested at 30 ppb, 16 ppb and 16 ppb, respectively. Since follow-up testing indicated that the elevated levels of lead appeared to be caused by the components of the water faucets, these water faucets were secured rendering them unusable. New faucets will be installed and additional follow-up testing will be conducted to verify that the new faucets are below the screening level of 15 ppb.

The *Corrective Actions* column describes actions that are being implemented to remediate the source of lead. In the event that fixtures or upstream piping are replaced (e.g. faucets in rooms 104 and 125), there are columns for additional follow-up testing data. This testing will be conducted once the fixtures are replaced to confirm that the corrective actions are successful in reducing lead below 15 ppb.
