Subj: U.S. NAVAL SUPPORT ACTIVITY, NAPLES, ITALY SUPPORT SITE YOUTH-TEEN CENTER DRINKING WATER

Overview of Testing Results for Lead in Drinking Water and Corrective Actions for NSA Naples Support Site Youth-Teen Center (YTC) (Building 2072)

SUPPORT SITE YOUTH/TEEN CENTER
BLDG. 2072
GROUND FLOOR

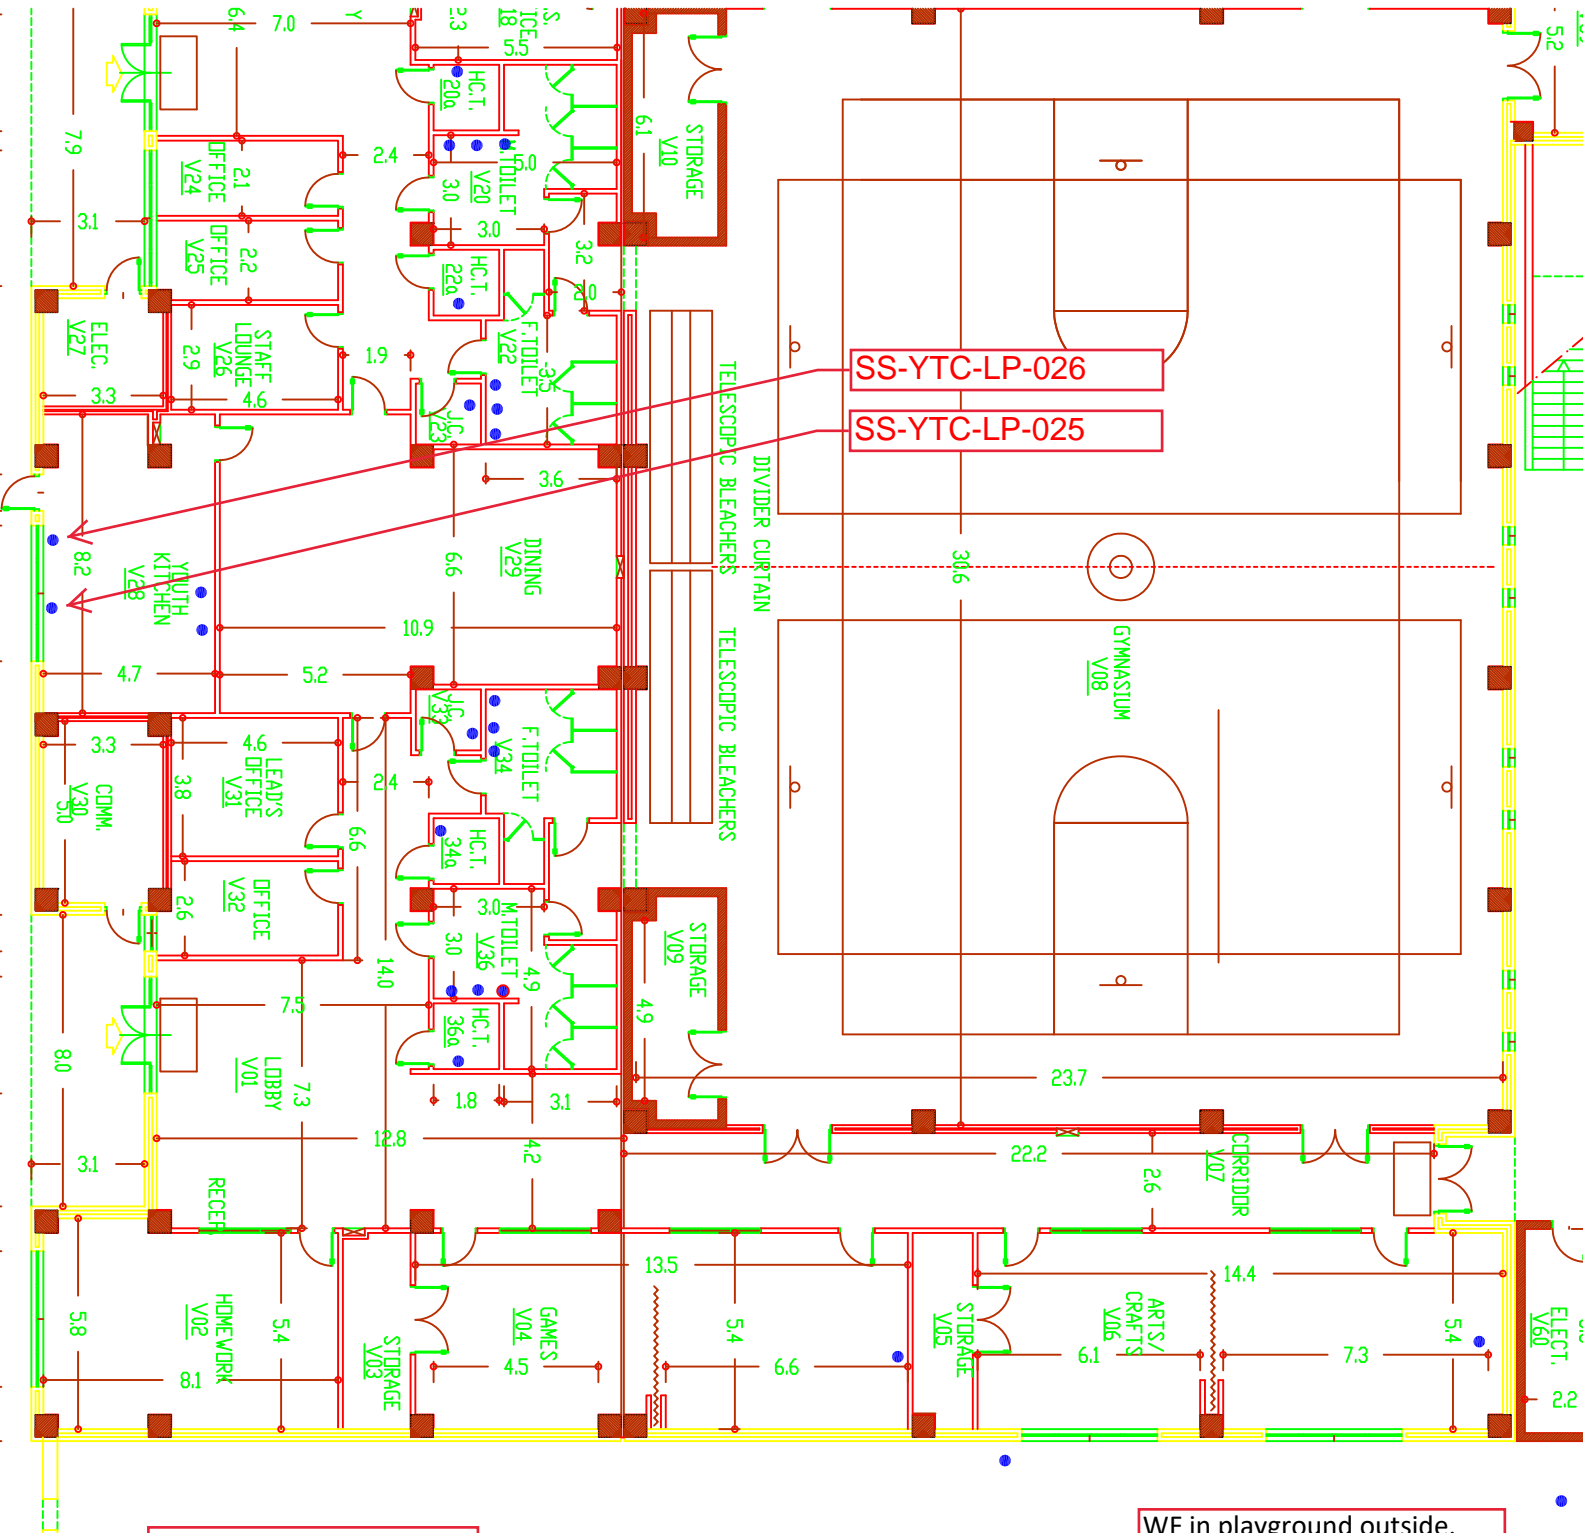
The three outlets that exceeded the screening level of 15 ppb were two kitchen sinks located in room 28.1 and a water fountain in the playground outside Bldg. 2072, which tested at 19 ppb, 19 ppb and 24 ppb, respectively. Since follow-up testing indicated that the elevated levels of lead appeared to be caused by the components of the water faucets, these water faucets were secured rendering them unusable. New faucets will be installed and additional follow-up testing will be conducted to verify that the new faucets are below the screening level of 15 ppb.

SS-YTC-LP-026
SS-YTC-LP-025

SS-YTC-LP-028

WF in playground outside,
northeast of Bldg. 2072

The *Corrective Actions* column describes actions that are being implemented to remediate the source of lead. In the event that fixtures or upstream piping are replaced (e.g. faucets in rooms 28.1 (two outlets) and the water fountain, there are columns for additional follow-up testing data. This testing will be conducted once the fixtures are replaced, to confirm that the corrective actions are successful in reducing lead below 15 ppb.
